# BS5837 Arboricultural Impact Assessment

Aylesbury Estate, FDS Site, Southwark, London

Client: Notting Hill Housing Association

Job Reference: 02027R

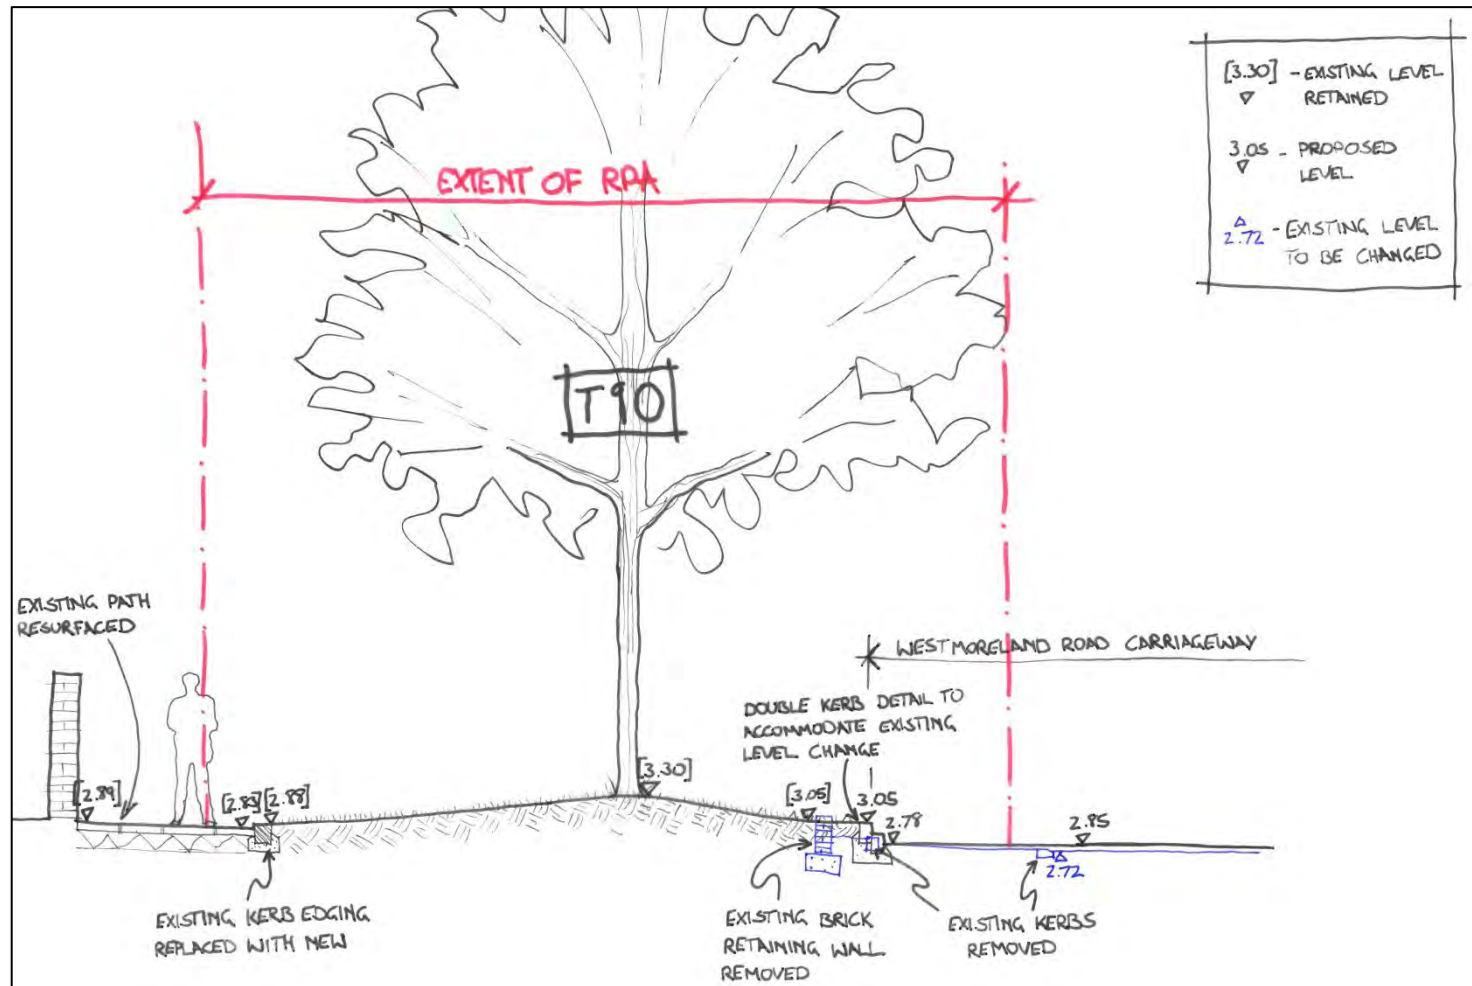
5.2.5 Sample HTA architect cross section sketch detailing works on Westmoreland Road (shown for T90):

BS 5837 Cat	A	B	C	Summary
RPA Incursion	-	T88, T89, T90, T91, T92, T93, T106, T107, T108, T109	T94	<p>There will be a remodeling of the existing hard standing area to accommodate new parking. This has been designed to minimize issues associated with ground level changes. We would propose that the final detail, to include an appropriate <b>site supervision</b> program be secured by way of <b>Planning Condition</b></p> <p><b>Site Supervision</b> – Site supervision supported with site specific method statements will be a key consideration of the project.</p>
RPA Incursion	-	T52 & T54	T39, T41, T53	<p><b>T39 &amp; T41</b> - These trees are to be retained within a new internal amenity space and there will be associated hard and soft landscape works within the RPA areas.</p> <p><b>T52, T53 &amp; T54</b> - These trees are to be retained within existing site edge amenity space and there will be associated hard and soft landscape works within the RPA areas.</p> <p>The full detail of these works is proposed to be dealt with by way of detailed <b>Method Statement</b> secured by <b>Planning Condition</b>.</p>

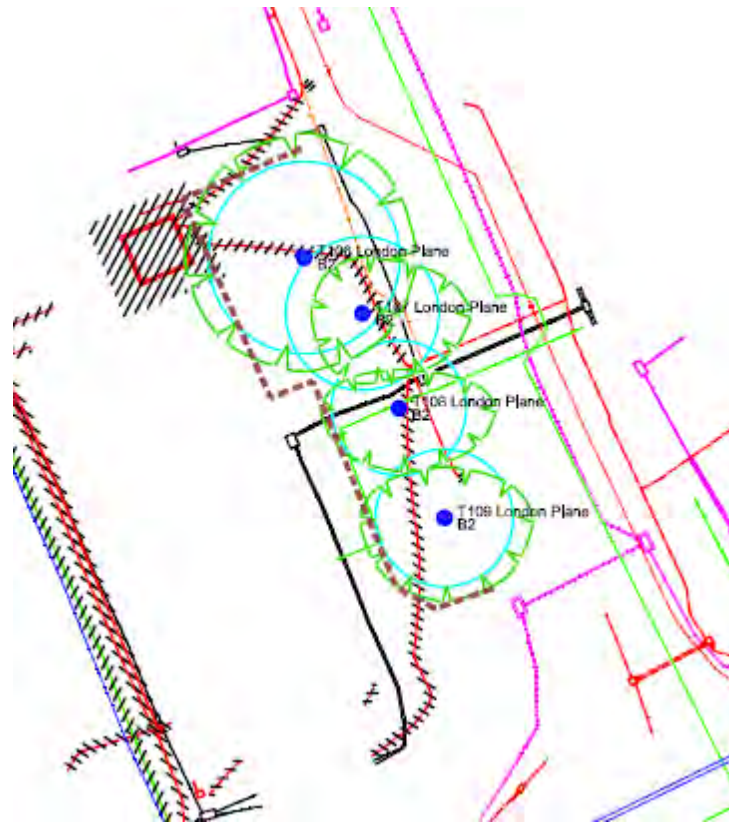
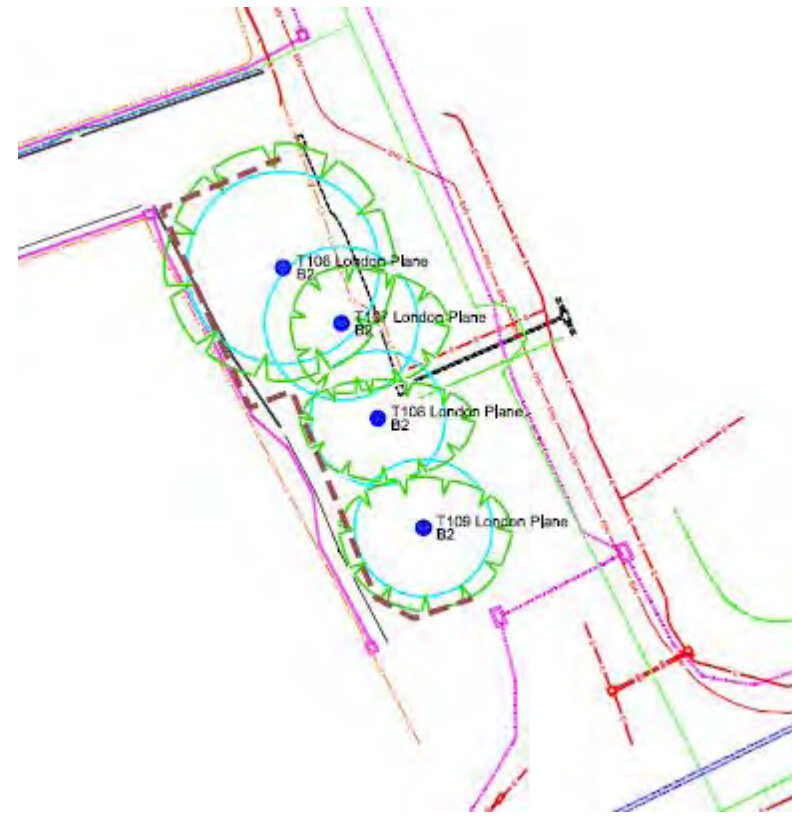
Existing site service runs (redundancies) shown on the left with proposed on the right. No new services within this area delivering an improvement on the current position.

- 5.6.1 Redevelopments of this size will require multiple service changes. These will involve making redundant/ safe the existing site services and new service provision.
- 5.6.2 Plans detailing the location of existing services are included within Appendix 6. Exact detail on service removal and installation methods is not yet known but there are likely to be requirements for hand digging within the RPA areas of retained trees T52, T53 & T54 as well as T106, T107, T108 & T109.
- 5.6.3 It is proposed that detail relating to the form and method of this service installation is secured by way of **Planning Condition** and when exact detail on removal/ installation methods is known this can be addressed within a site specific **Method Statement**.

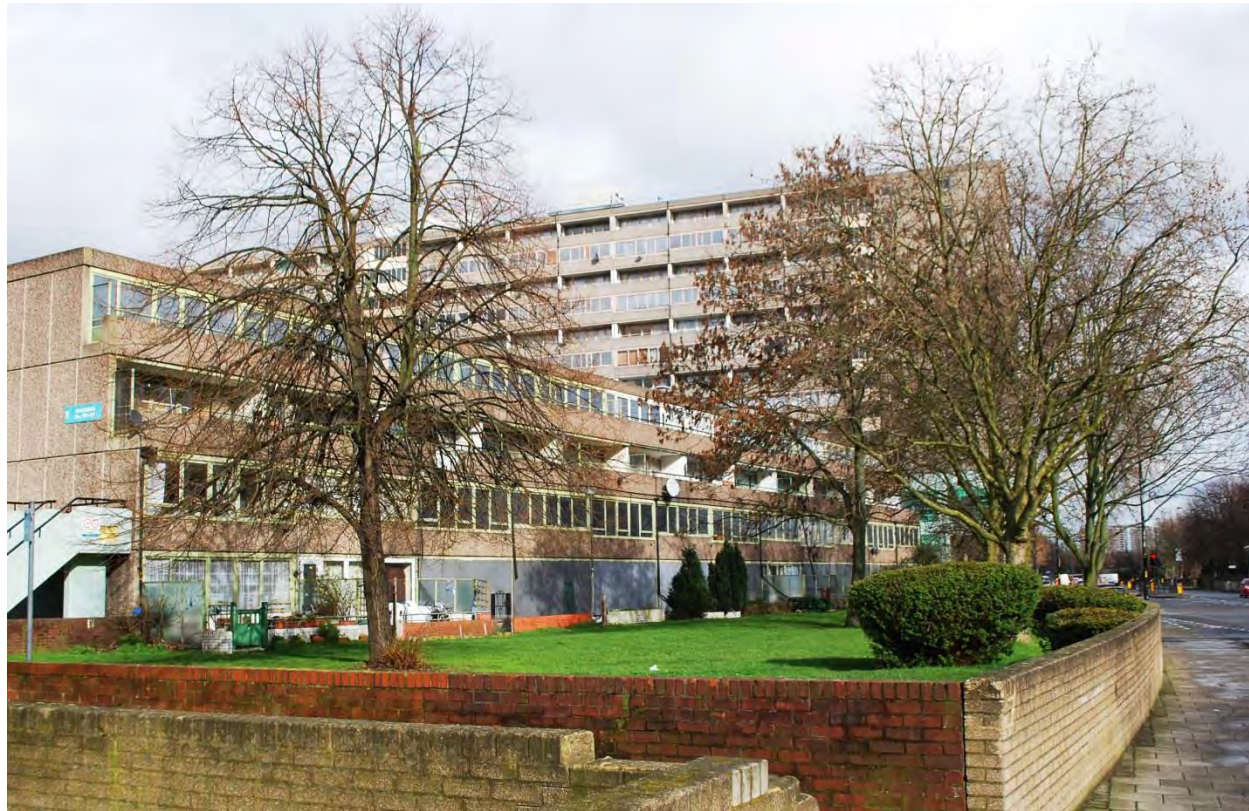
**Image 1** – Retained trees T52, T53 & T54 visible to right

5.2.3 Internally retained trees T39, T41, T52, T53 and T54 will be specifically fenced prior to any on site demolition. To be effective it is proposed that the full BS5837 fencing specification be used.

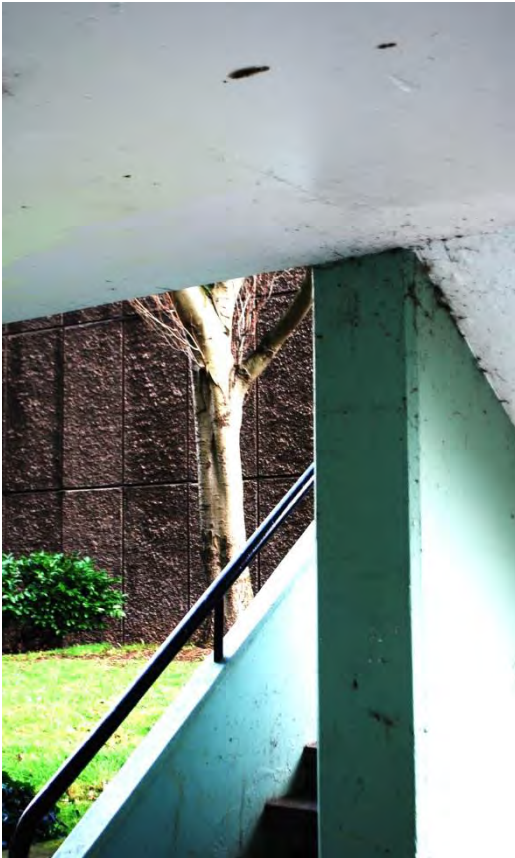
**Image 2** – Basal stem of retained tree T41 showing proximity to building and levels. Protection prior to any on site demolition is required to successfully retain this tree

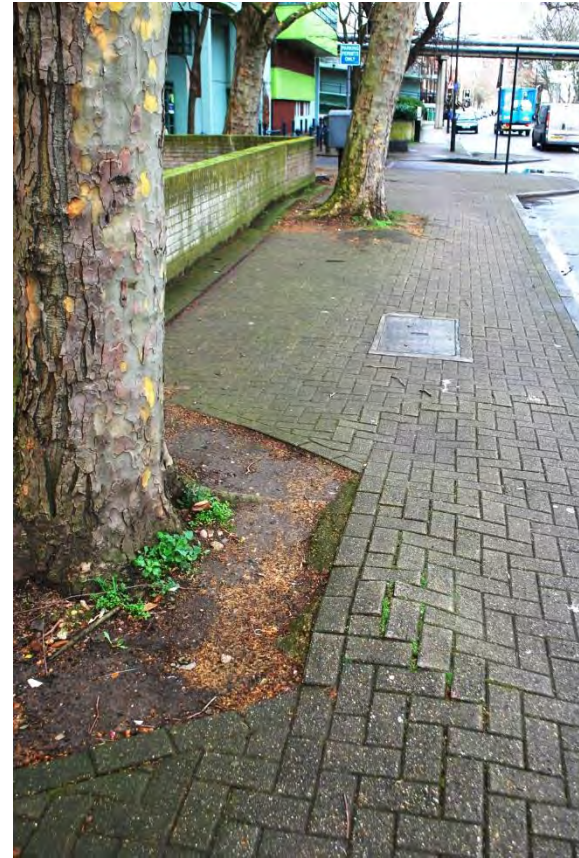
**Image 3** – Stem bases of T108 & T107 – site supervision and hand working required to ensure surface roots are not damaged

5.2.2 Due to the RPA encroachment of T106, T107, T108 & T109 in to the site it is proposed that BS5837 compliant fencing be used to secure the integrity of that area during demolition and construction works. The physical removal and replacement of hard standings within this area will be dealt with

by way of detailed **Method Statement** and it is advised this is secured by way of a suitable **Planning Condition**. This should also address the removal of hard standing and revised hard landscaping for trees on Westmoreland Road (T88, T89, T90, T91, T92, T93 & T94).

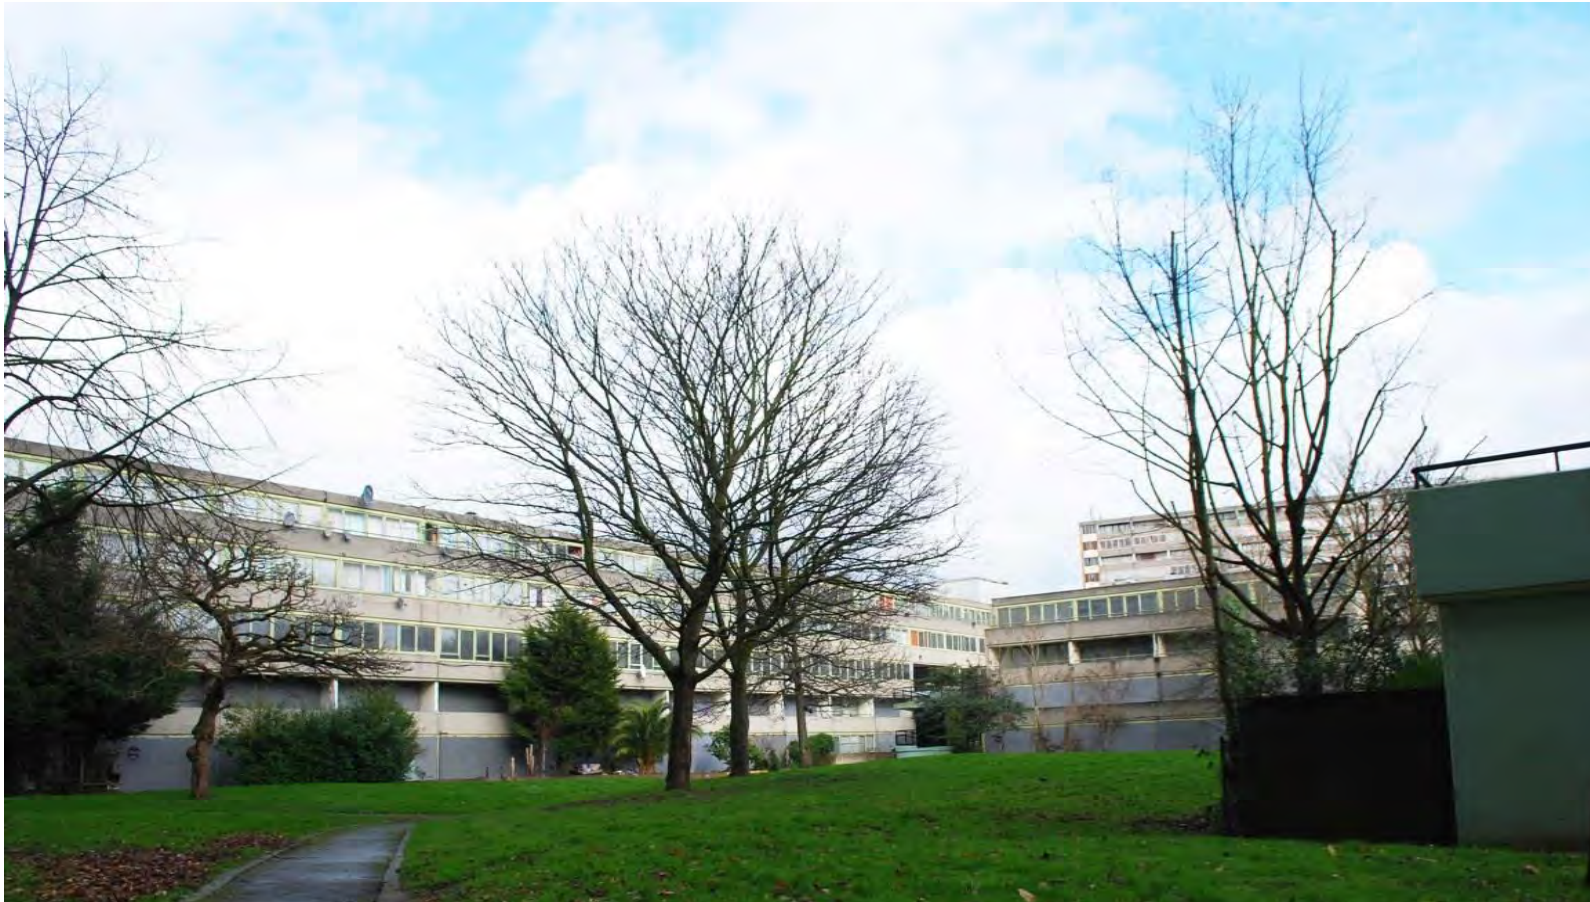
**Image 4** – Internal trees are generally of lower public amenity. Extreme canopy of retained Lime (T39) visible to left hand side
