# BS5837 Arboricultural Impact Assessment

Aylesbury Estate, FDS Site, Southwark, London

Client: Notting Hill Housing Association

Job Reference: 02027R

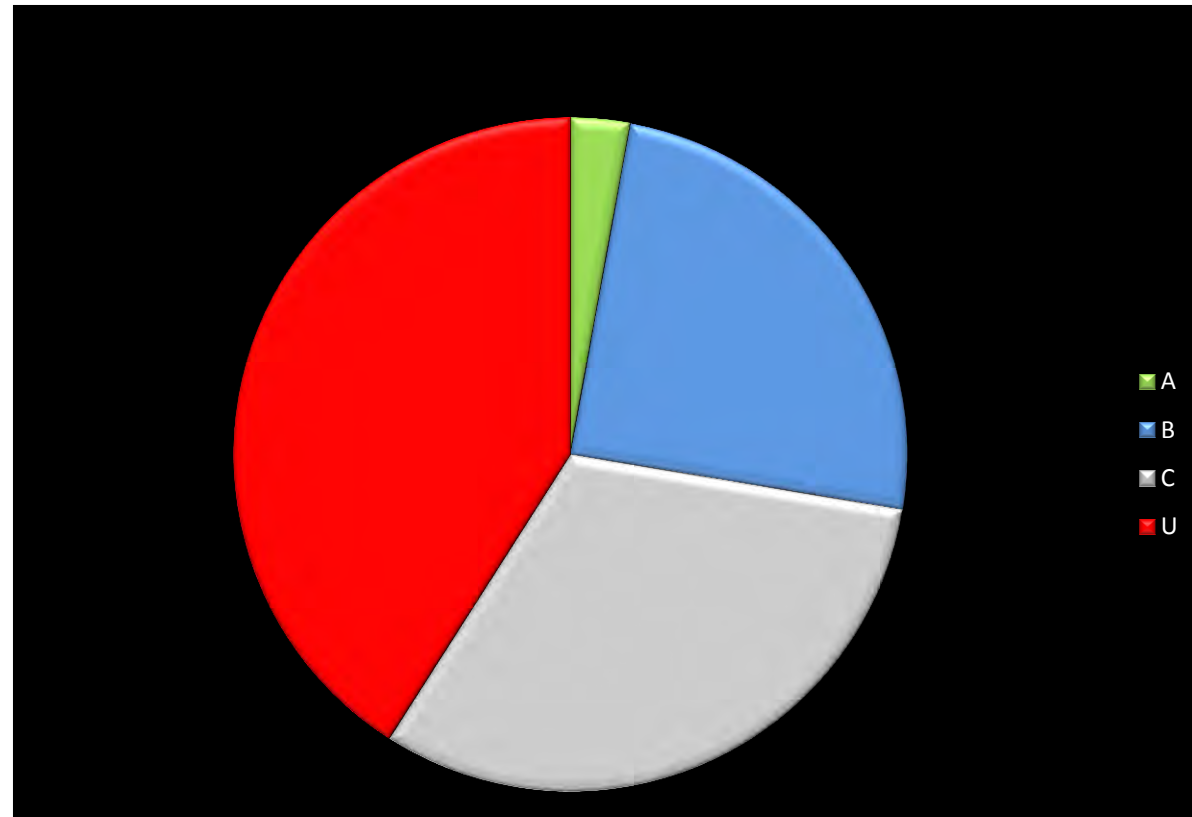
4.2 A visual representation of the BS5837 Tree Categories is shown below. This demonstrates that the current tree stock is predominantly BS5837 C & U Cat (lower quality trees).

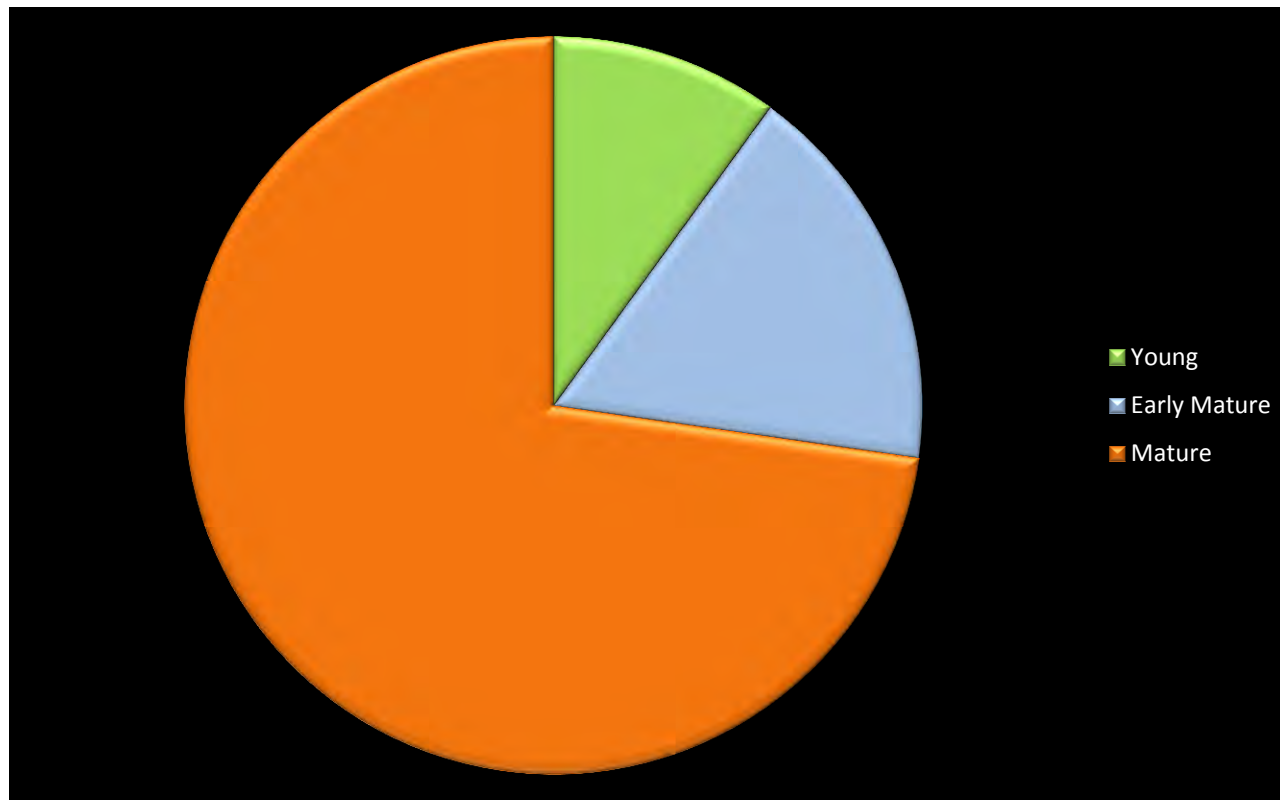
4.3 A visual representation of the Age Class distribution shows that the trees are predominantly mature. A sustainable tree stock should have a much greater mix of Age Class distribution than is currently present and the redevelopment affords a real opportunity to deliver a lasting improvement to in both quality and age class distribution.

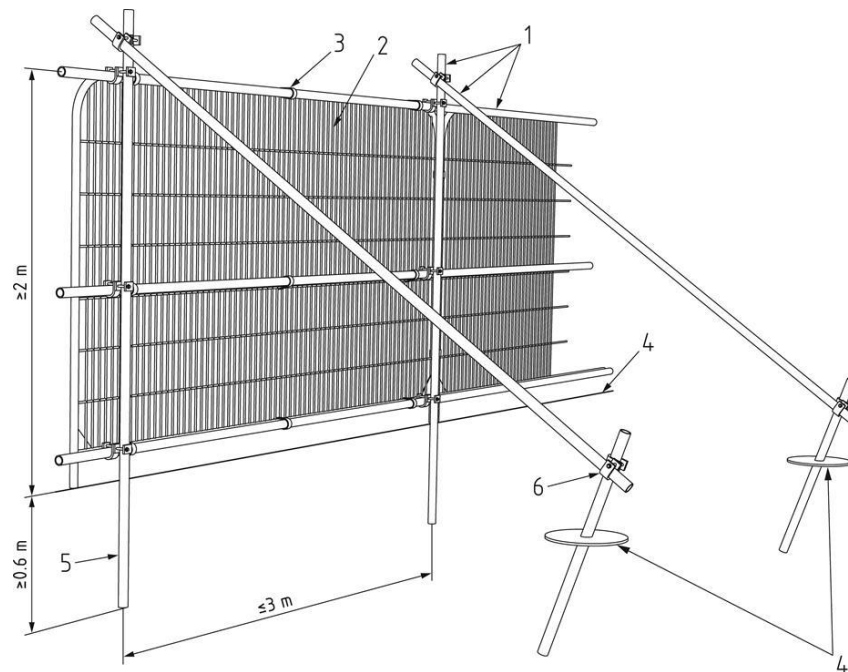
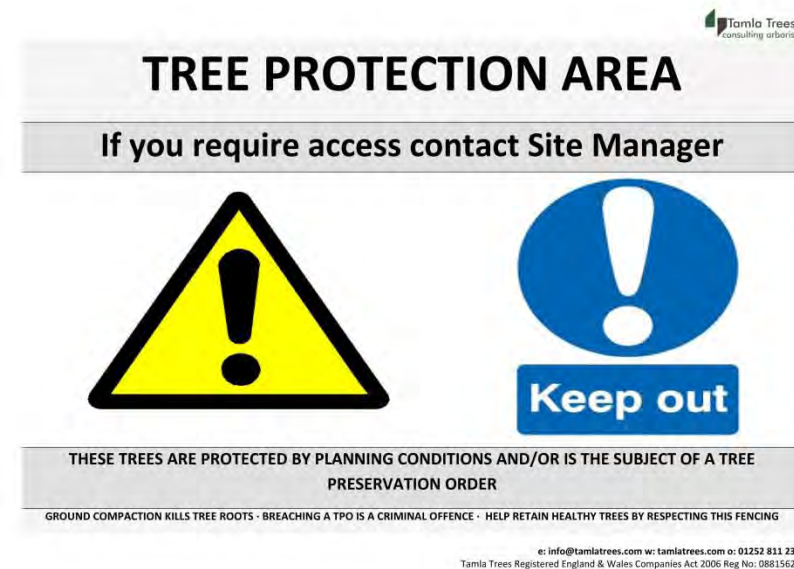
5.2.3 Internally retained trees T39, T41, T52, T53 and T54 will be specifically fenced prior to any on site demolition. To be effective it is proposed that the full BS5837 fencing specification be used.

**To be effective fencing must be robust and clearly signed**

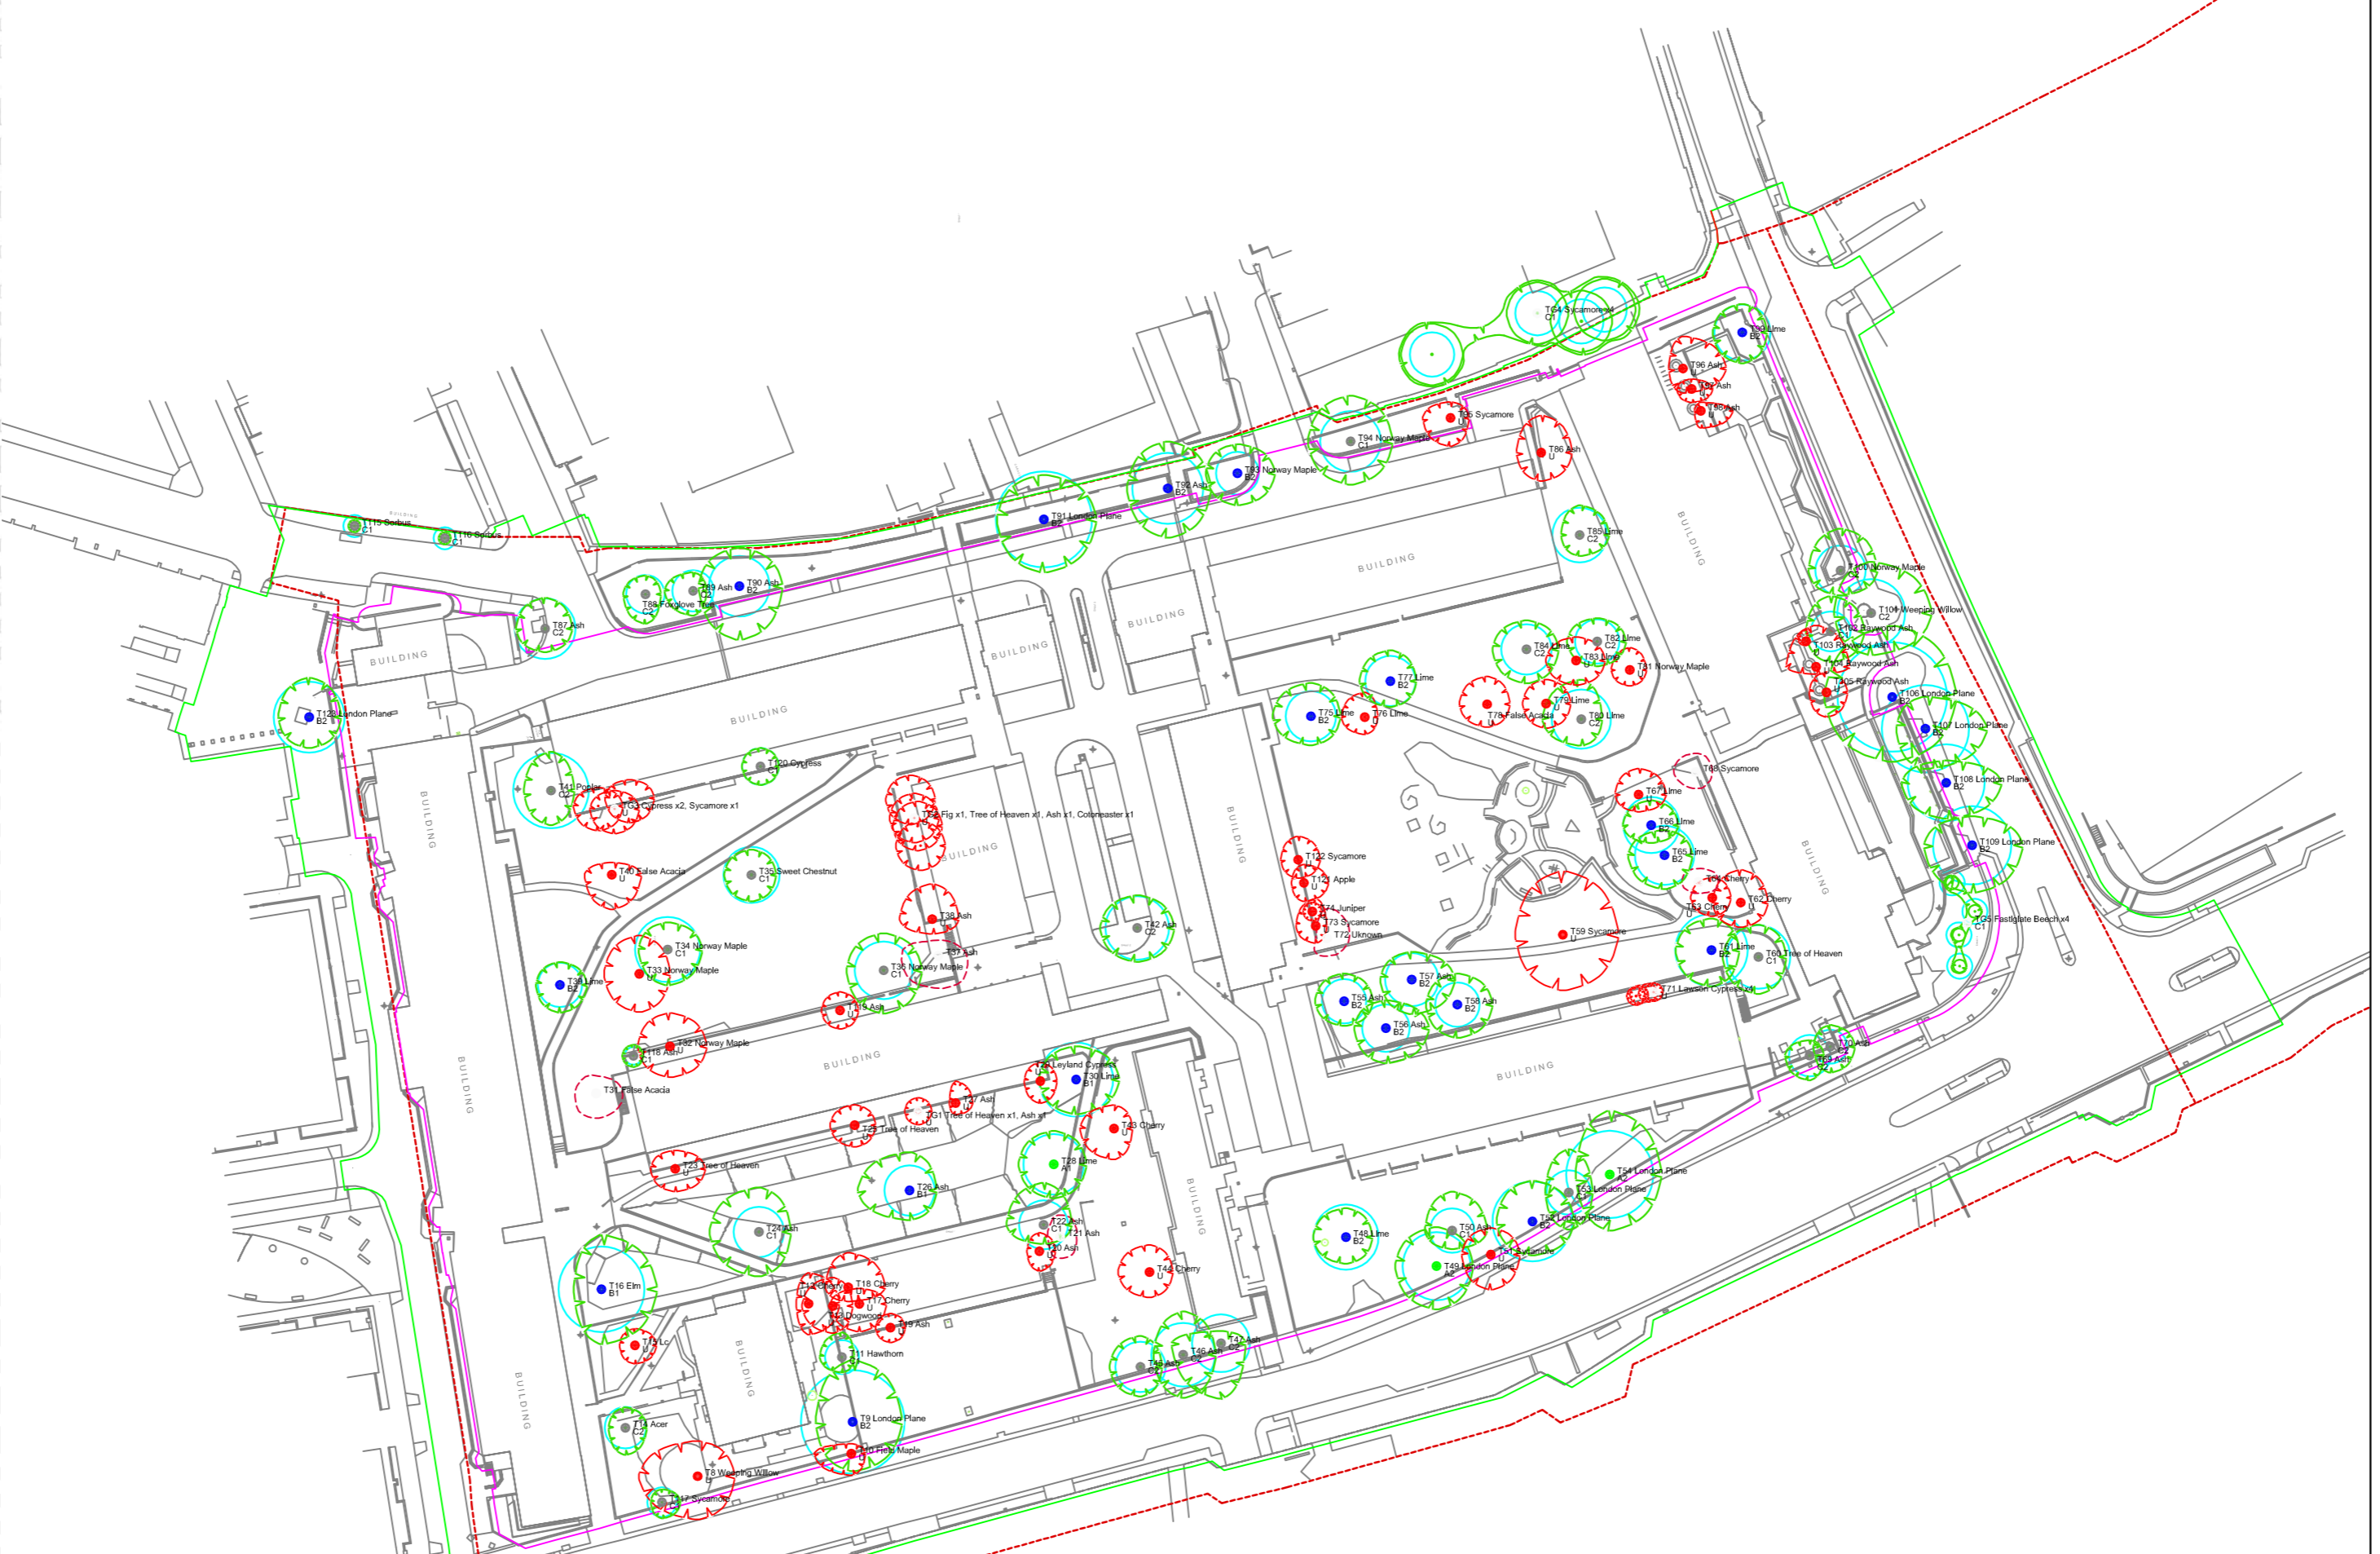
# Appendix 3 - Tree Constraints Plan

T116	Plane (London)	0.24	Mature	> 40	Exposed surface rooting and close to wall. Generally ok.	B2	4.8
T117	Plane (London)	0.59	Mature	> 40	Near boundary wall and slight asymmetry.	B2	7.1
T118	Plane (London)	0.52	Mature	> 40	Subject to previous pruning. Stem wound.	B2	6.2
T119	Plane (London)	0.53	Mature	> 40	Cavity on main stem. Asymmetric canopy.	B2	6.4
T120	Fragaria Beach x1				New TSS.	0	
T121	Sycamore				Removed.	0	
T122	Sycamore				Removed.	0	
T123	Sycamore				Removed.	0	
T124	Sycamore				Removed.	0	
T125	Sorbus	0.15	Early-mature	10 to 20	Poor quality street tree planting.	C1	1.8
T126	Sorbus	0.18	Early-mature	10 to 20	Poor quality street tree planting.	C1	1.8
T127	Sycamore	0.3	Young	20 to 40	Self-set tree suppressed by 7m. Close to wall. Included union at 2.3m.	C1	2.4
T128	Ash	0.22	Young	20 to 40	Self set and drawn stem.	C1	1.4
T129	Ash	0.18	Early-mature	<10	Self set tree too close to building for retention.	U	2.2

T130	Cypress	0.29	Early-mature	<10	Nearly lost for retention 2.8m from building.	C1	3
T131	Apple	0.14	Mature	<10	Too close to building for retention.	U	1.7
T132	Sycamore	0.23	Early-mature	<10	Too close to building to be retained.	U	3
T133	Plane (London)	0.48	Mature	> 40	Retained in hard standing. Ivy establishment. Subject to cyclical pruning.	B2	5.7
T134	Tree of Heaven x1, Ash x1	0.9	Young	<10	Self set and poorly located for retention.	U	10.8
T135	Fig x1, Tree of Heaven x1, Ash x1, Cotoneaster x1	0.2	Early-mature	<10	Poorly located for retention. 2.6m from building.	U	2.4
T136	Cypress x2, Sycamore x1	0.3	Early-mature	<10	Poor quality and badly located for retention.	U	2.8
T137	Sycamore x4	0.3	Young	20 to 40	X1 3rd party so unable to fully inspect.	C1	3.6
T138	Fragaria Beach x1	0.09	Young	> 40	(Collectively identified as T110 previously). Establishing planting. Poor quality. These given and lost.	C2	1.1

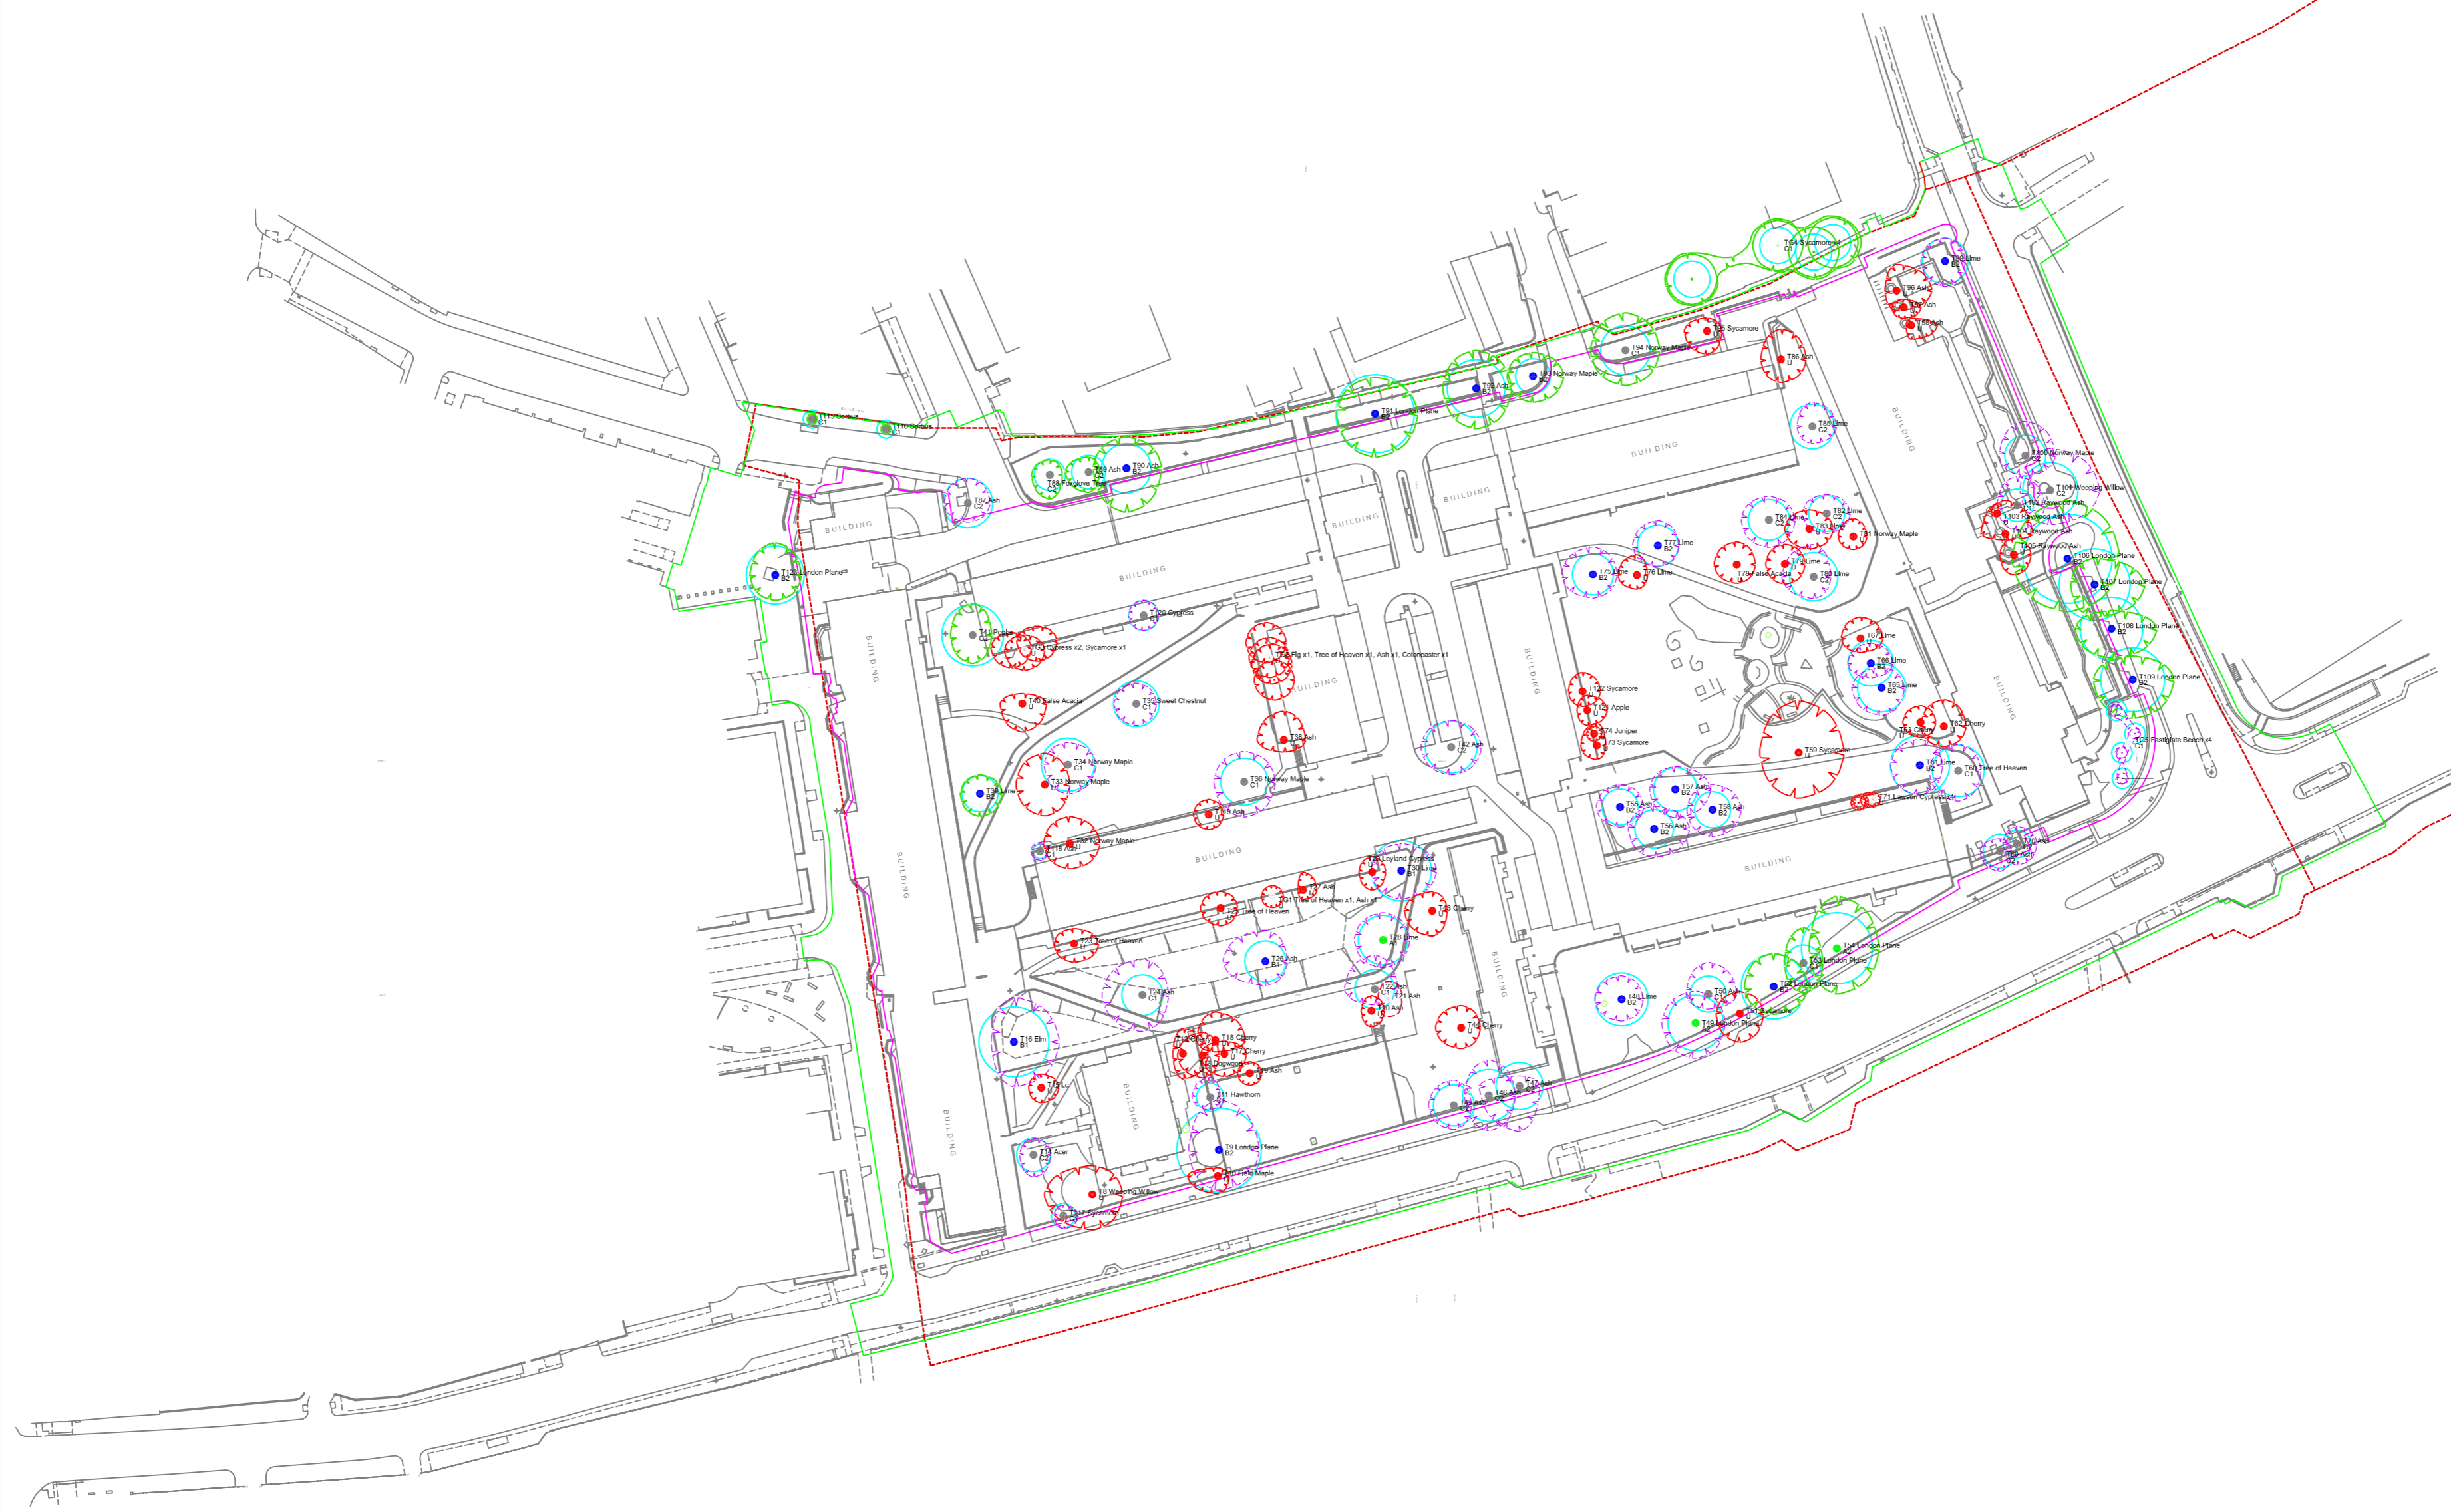
# Appendix 4 - Tree Removal Plan

- 1.6 Whilst the proposal will result in the loss of the majority of site trees modern arboricultural and landscape techniques will address the poor soil growing medium which should ensure that the replacement trees develop in to a much more effective arboricultural/ amenity resource.
